APPENDIX A: SOIL/FILL AREA/VOLUME DELINEATION INFORMATION

Remedial Footprint Information

Remedial investigation (RI) soil results and historical data were used to develop the footprints for the soil and soil gas remedial alternatives. Appendix A prepared by USEPA describes the methodology used to prepare these footprints; delineations will be completed during the remedial design. All of the data used for this evaluation are provided in Table 3-5A through Table 3-5D in the Feasibility Study (FS) Report. For each sample listed in the Table 3-5 series, information is provided on the property lot number, location identification (ID), sample date, depth interval in units of feet below ground surface (bgs), sample type (indicating a primary environmental sample or a quality control field duplicate), and information on the associated parent and field duplicate pair. The laboratory results and the associated qualifier are presented. The RI soil data were provided by PPG Industries, Inc. (PPG) and their consultants, Woodard & Curran, on January 17, 2020. The historical data were provided by PPG/Woodard & Curran as Appendix F of the 2015 Site Characterization Summary Report (SCSR).

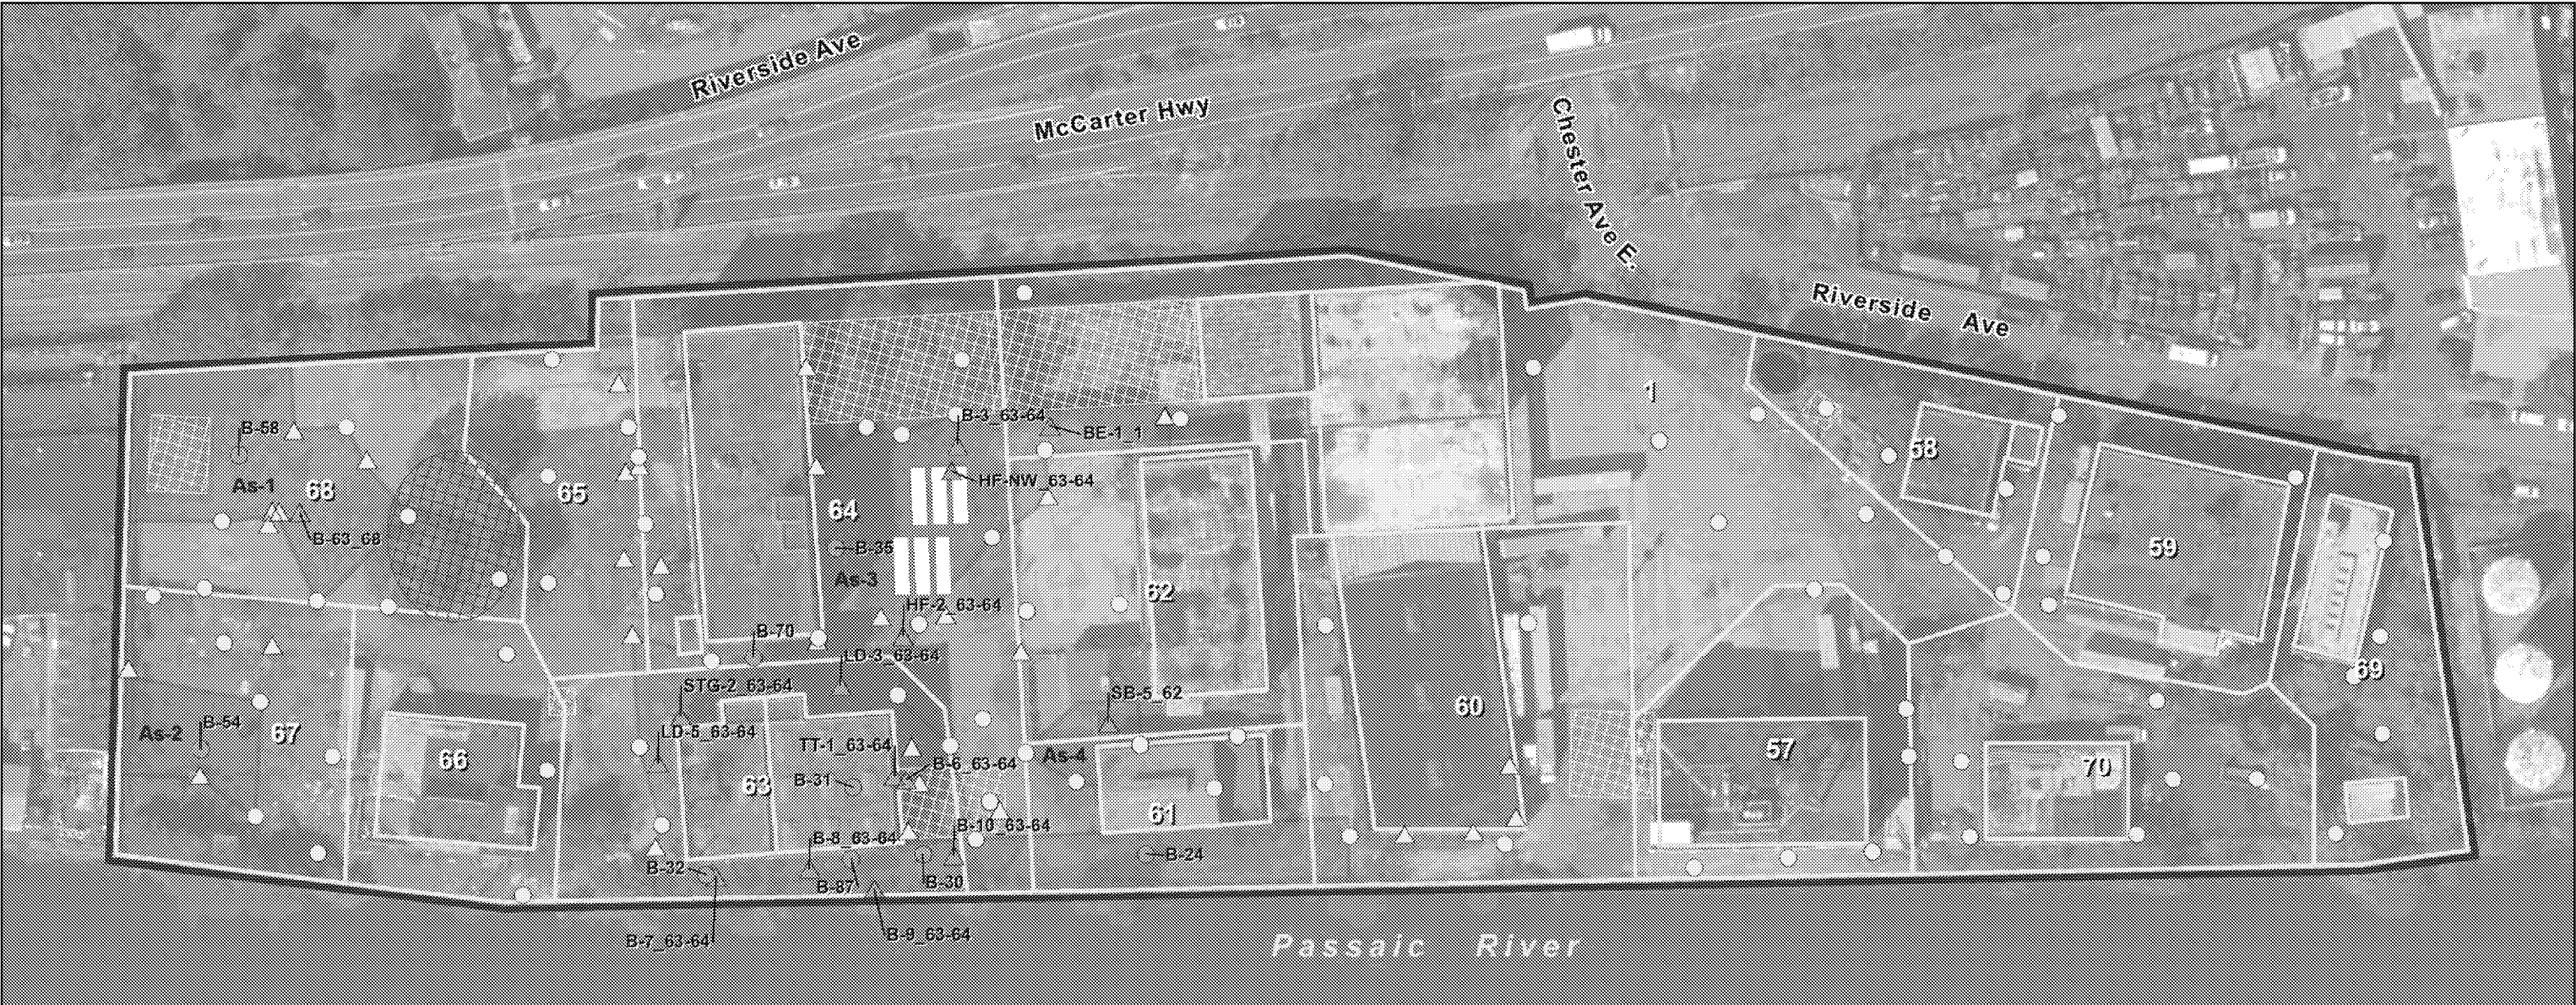
Figure A-1
Site-Wide Soil Sampling Results for
Soil Alternatives: Arsenic
Riverside Industrial Park Superfund Site
Essex County, New Jersey

Area	SqFt	Acres
As-1	9797.28	0.22
As-2	3557.01	0.08
As-3	29683.48	0.68
As-4	1495.11	0.03

Figure	COPCs	Area	SqFt	Acres
Figure A-1	Arsenic	As-1	9797.28	0.22
		As-2	3557.01	0.08
		As-3	29683.48	0.68
		As-4	1495.11	0.03
Figure A-2	Copper	Cu-1	5,743.13	0.13
		Cu-2	4,433.10	0.1
		Cu-3	2,438.08	0.06
		Cu-4	2,091.23	0.05
Figure A-3	Lead	Pb-1	18,516.69	0.43
		Pb-2	9,187.38	0.21
		Pb-3	26,921.45	0.62
		Pb-4	4,740.73	0.11
		Pb-5	26,631.58	0.61
		Pb-6	9,187.91	0.21
Figure A-4	Benzo(a)anthracene	B(a)A-1	3,275.03	0.08
Figure A-5	Benzo(a)pyrene	B(a)P-1	10,480.44	0.24
		B(a)P-2	8,259.46	0.19
		B(a)P-3	688	0.02
		B(a)P-4	2,542.09	0.06
		B(a)P-5	7,060.72	0.16
		B(a)P-6	2,275.93	0.05
		B(a)P-7	1,740.20	0.04
		B(a)P-8	12,753.11	0.29
		B(a)P-9	6,776.92	0.16
		B(a)P-10	7,554.76	0.17
		B(a)P-11	4,473.71	0.1
		B(a)P-12	1,048.54	0.02
		B(a)P-13	2,821.15	0.06
		B(a)P-14	3,193.07	0.07
Figure A-6	Benzo(b)fluoranthene	B(b)F-1	3,273.98	0.08

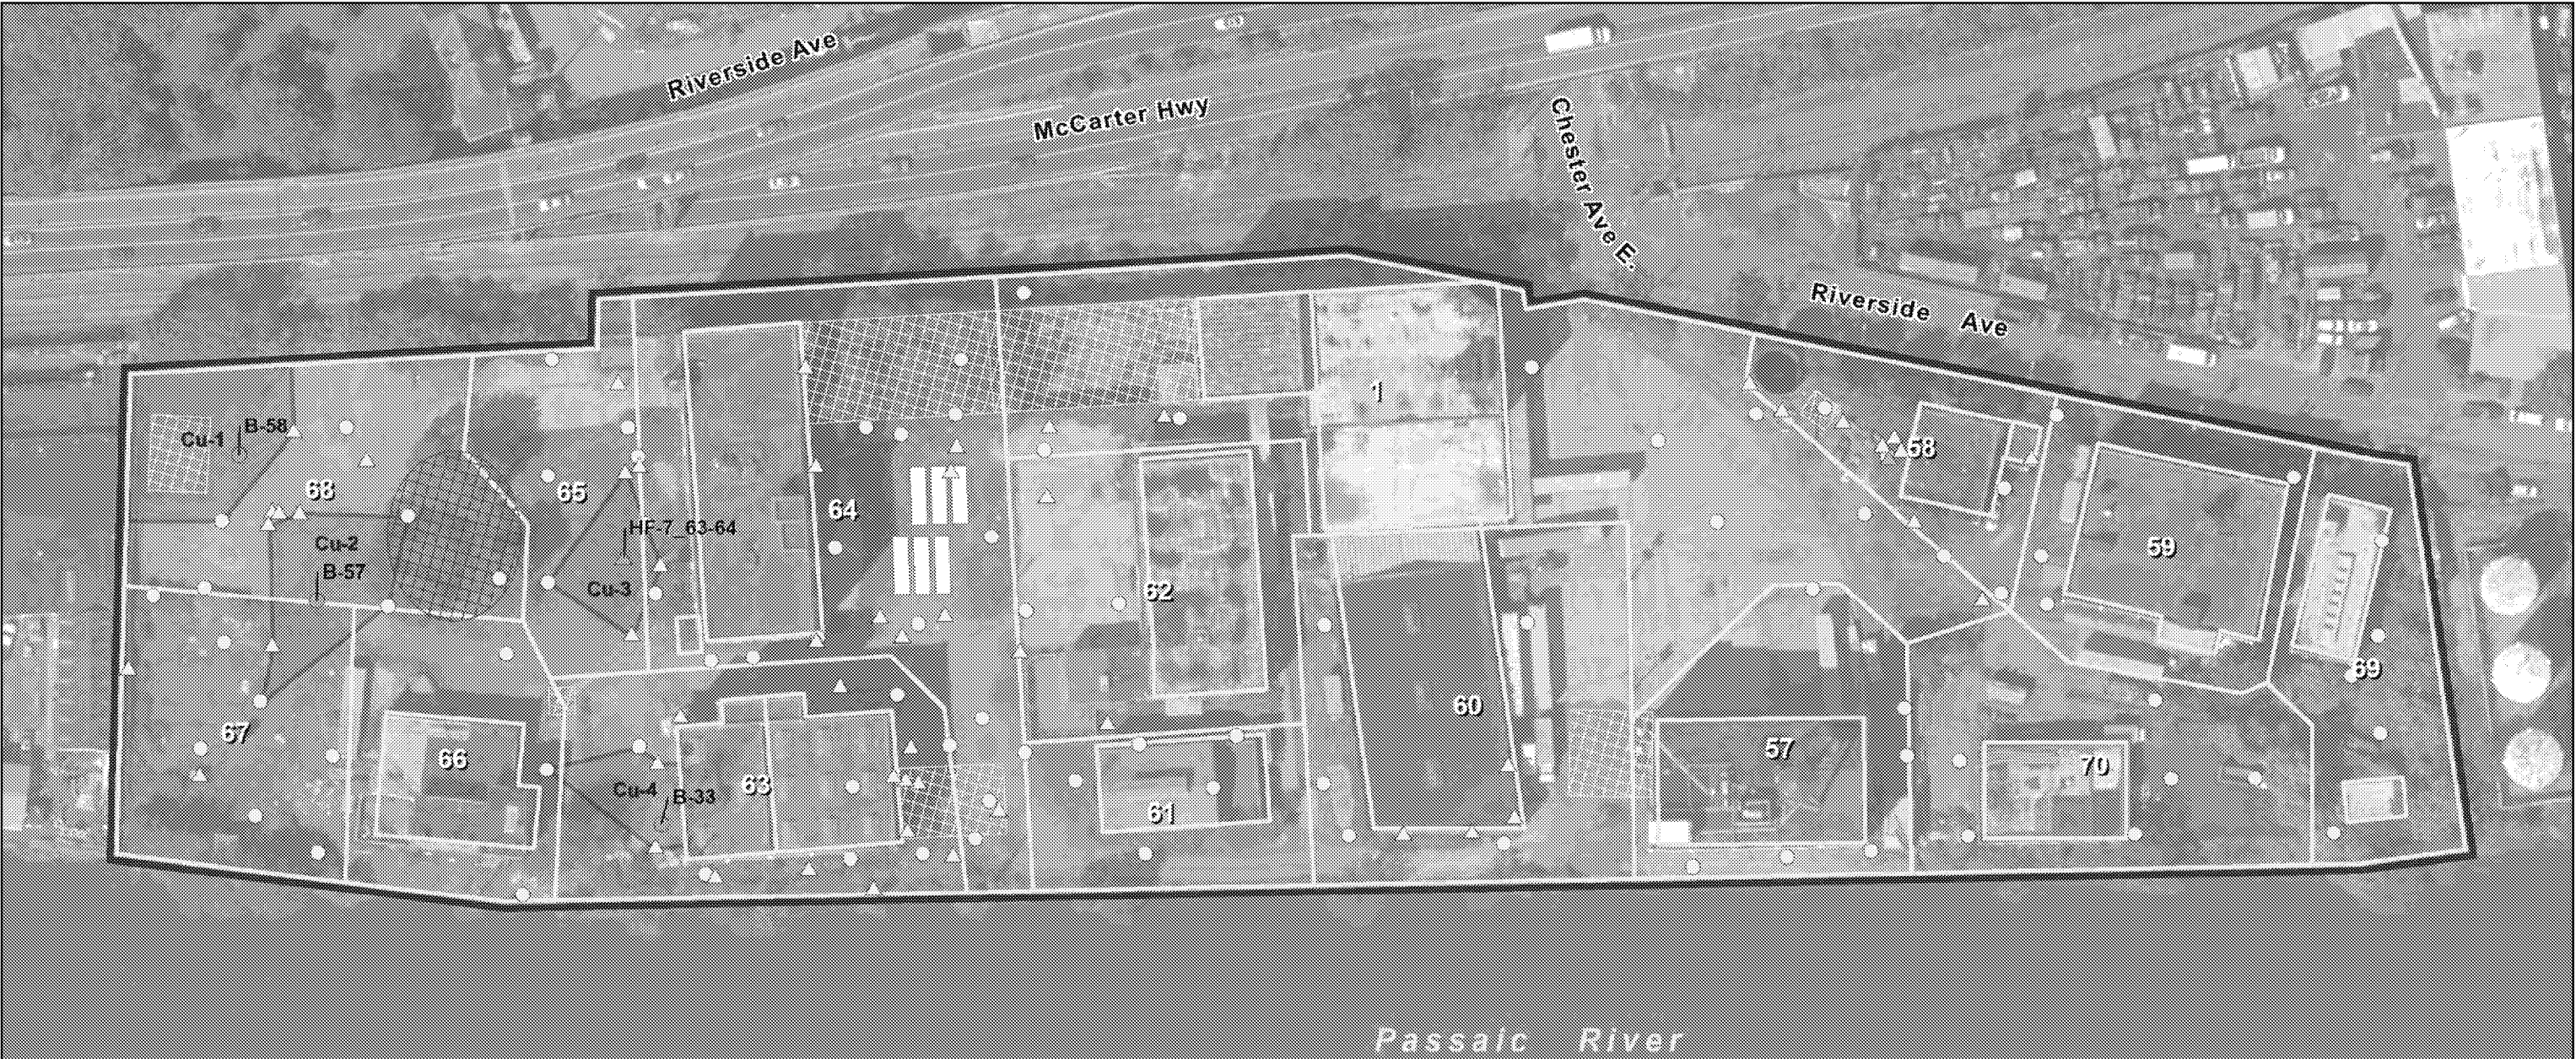
Figure A-2
Site-Wide Soil Sampling Results for
Soil Alternatives: Copper
Riverside Industrial Park Superfund Site
Essex County, New Jersey

Area	SqFt	Acres
Cu-1	5,743.13	0.13
Cu-2	4,433.10	0.10
Cu-3	2,438.08	0.06
Cu-4	2,091.23	0.05

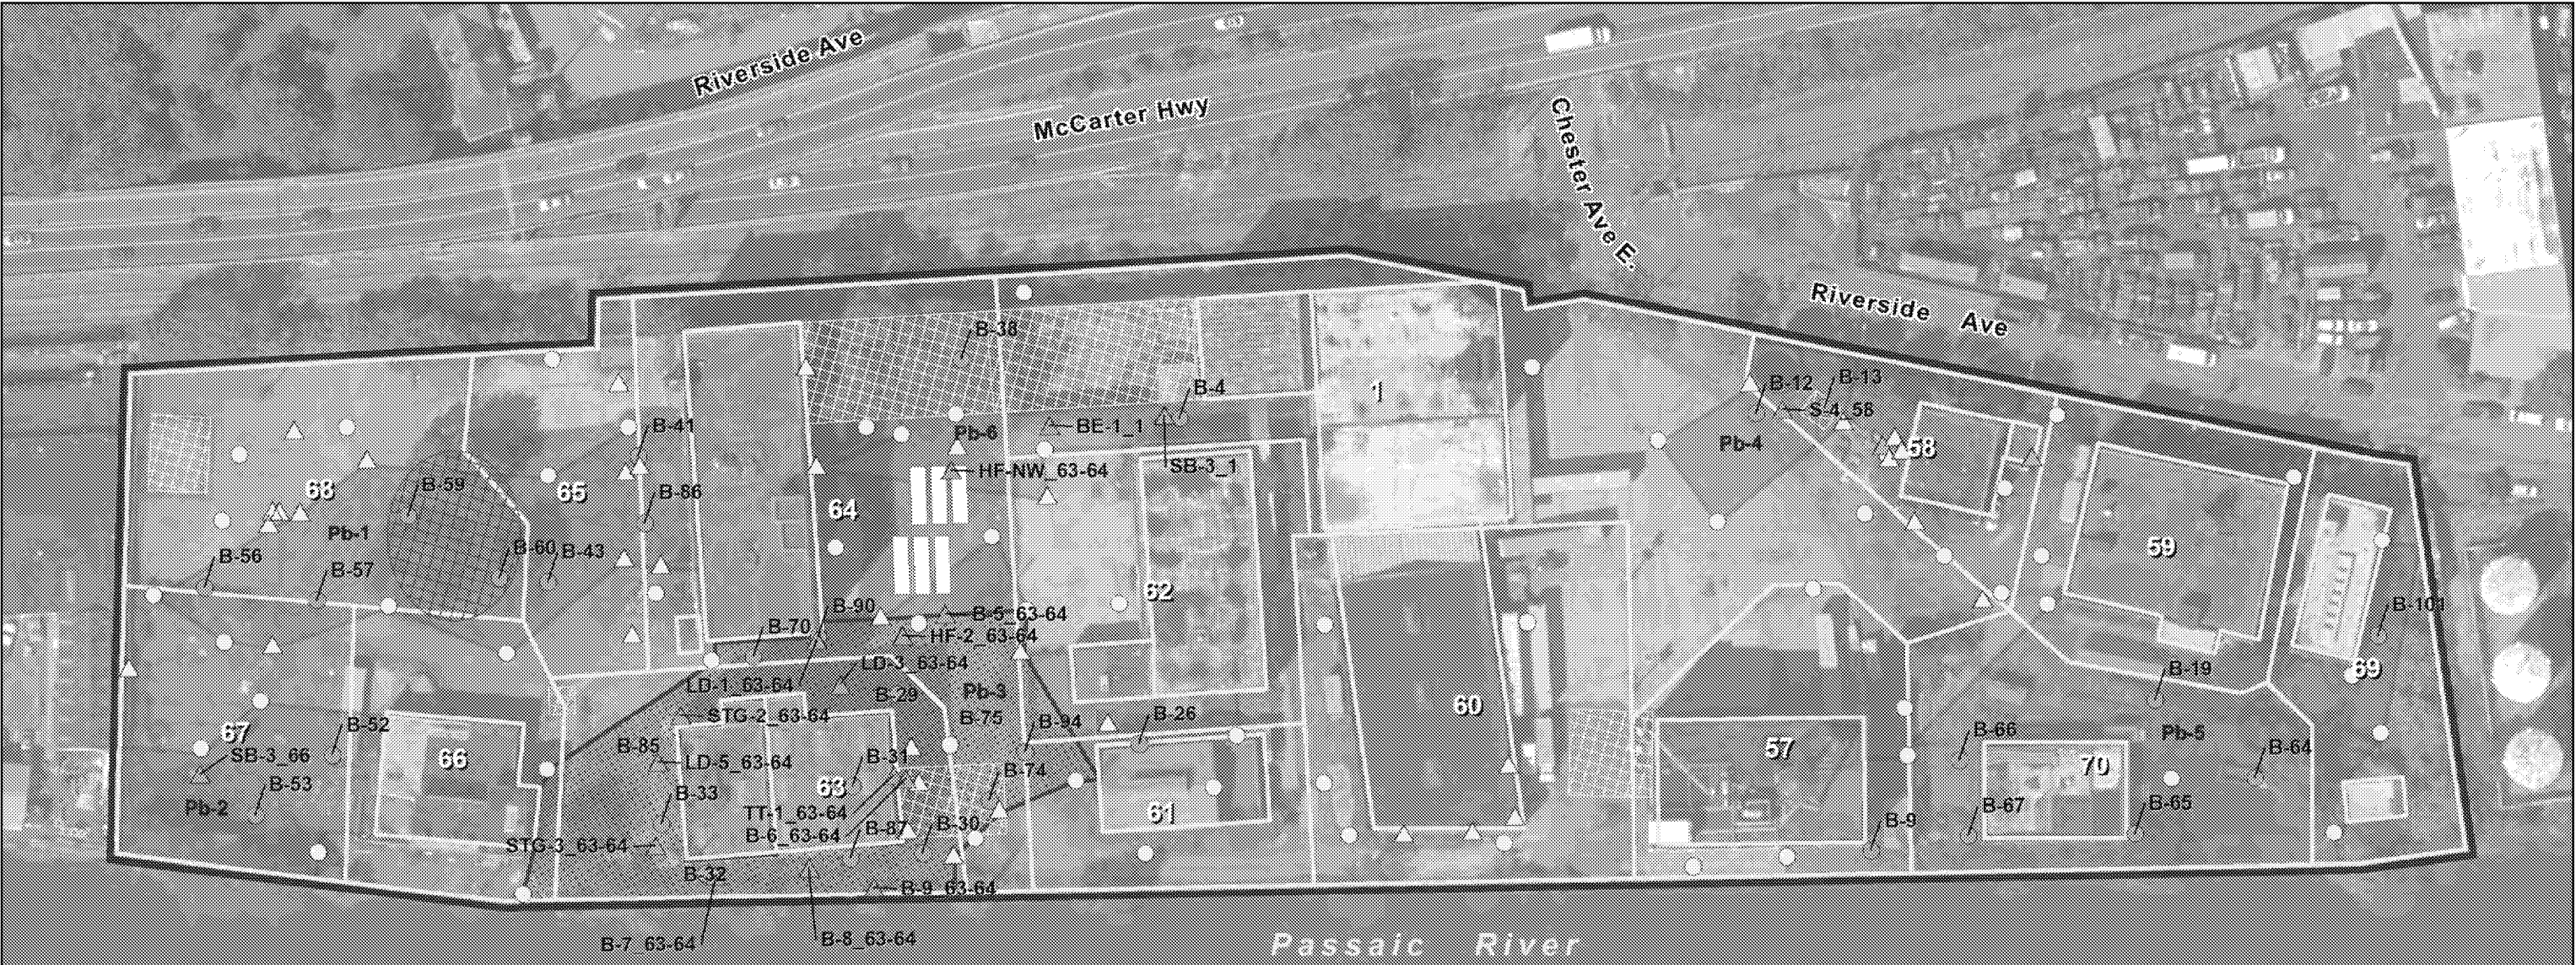
Figure A-3

Area	SqFt	Acres
Pb-1	18,516.69	0.43
Pb-2	9,187.38	0.21
Pb-3	26,921.45	0.62
Pb-4	4,740.73	0.11
Pb-5	26,631.58	0.61
Pb-6	9,187.91	0.21

Site-Wide Soil Sampling Results for Soil Alternatives: Lead

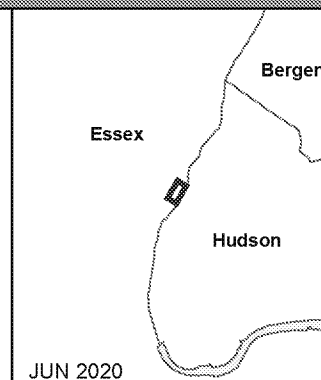
Figure A-4
Site-Wide Sample Results for
Soil Alternatives: Benzo(a)anthracene
Riverside Industrial Park Superfund Site
Essex County, New Jersey

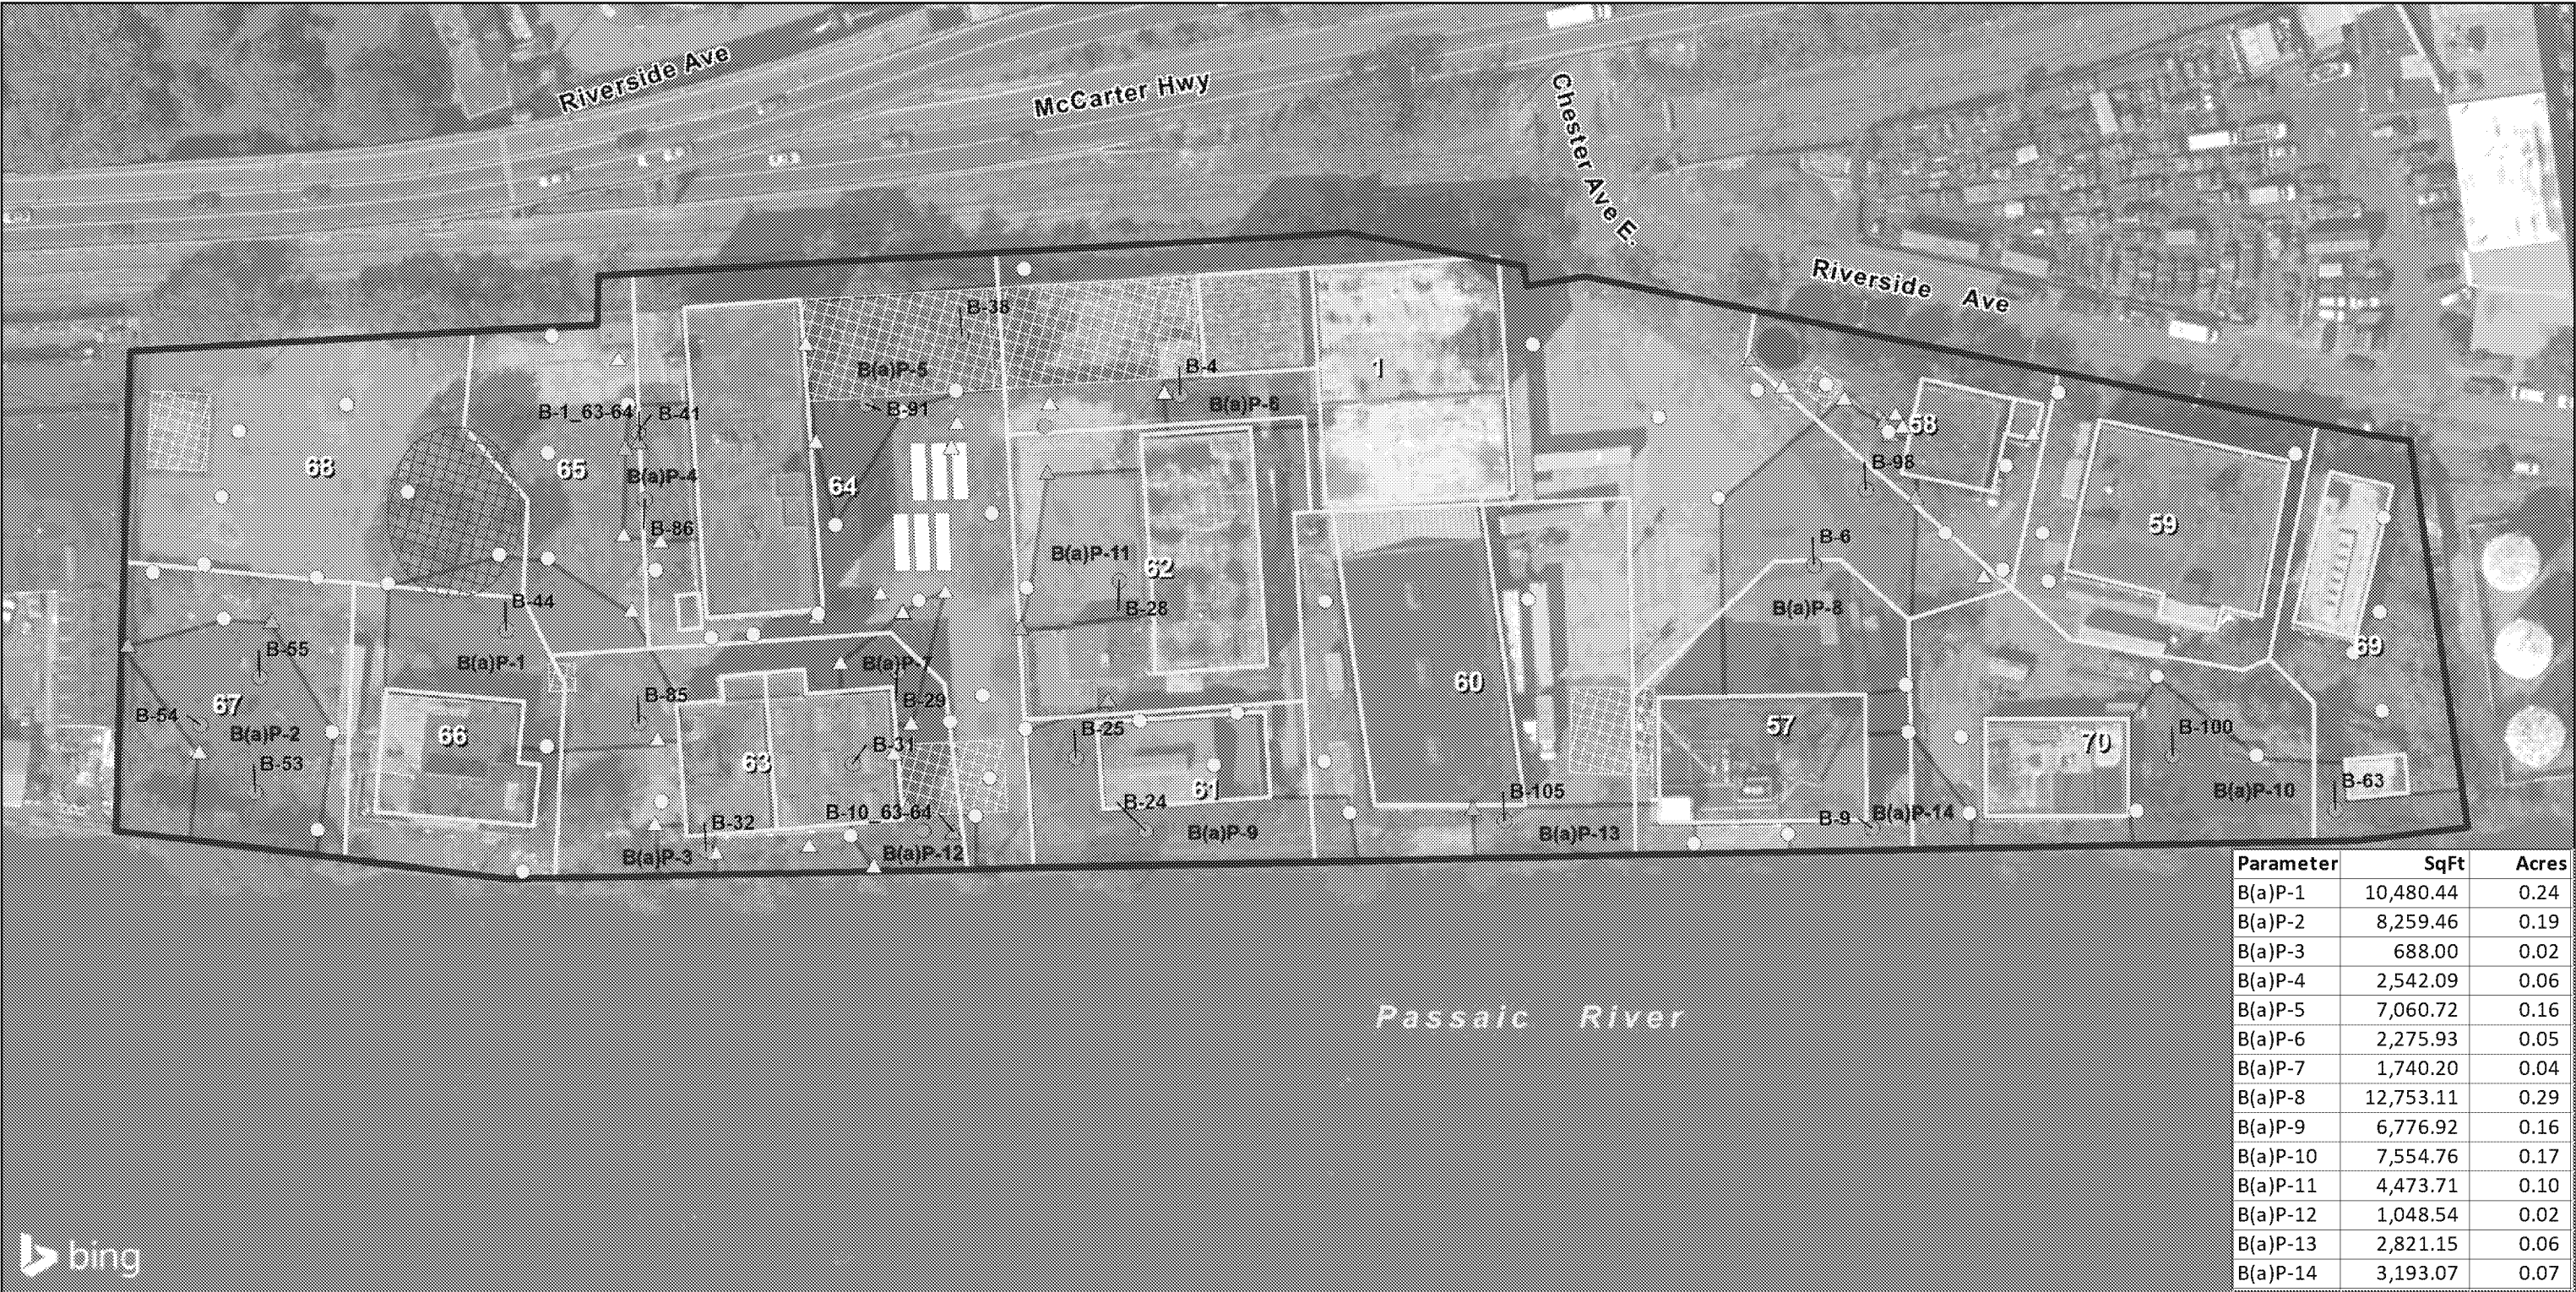
Figure A-5

Parameter	SqFt	Acres
B(a)P-1	10,480.44	0.24
B(a)P-2	8,259.46	0.19
B(a)P-3	688.00	0.02
B(a)P-4	2,542.09	0.06
B(a)P-5	7,060.72	0.16
B(a)P-6	2,275.93	0.05
B(a)P-7	1,740.20	0.04
B(a)P-8	12,753.11	0.29
B(a)P-9	6,776.92	0.16
B(a)P-10	7,554.76	0.17
B(a)P-11	4,473.71	0.10
B(a)P-12	1,048.54	0.02
B(a)P-13	2,821.15	0.06
B(a)P-14	3,193.07	0.07

Site-Wide Soil Sampling Results for Soil Alternatives: Benzo(a)pyrene

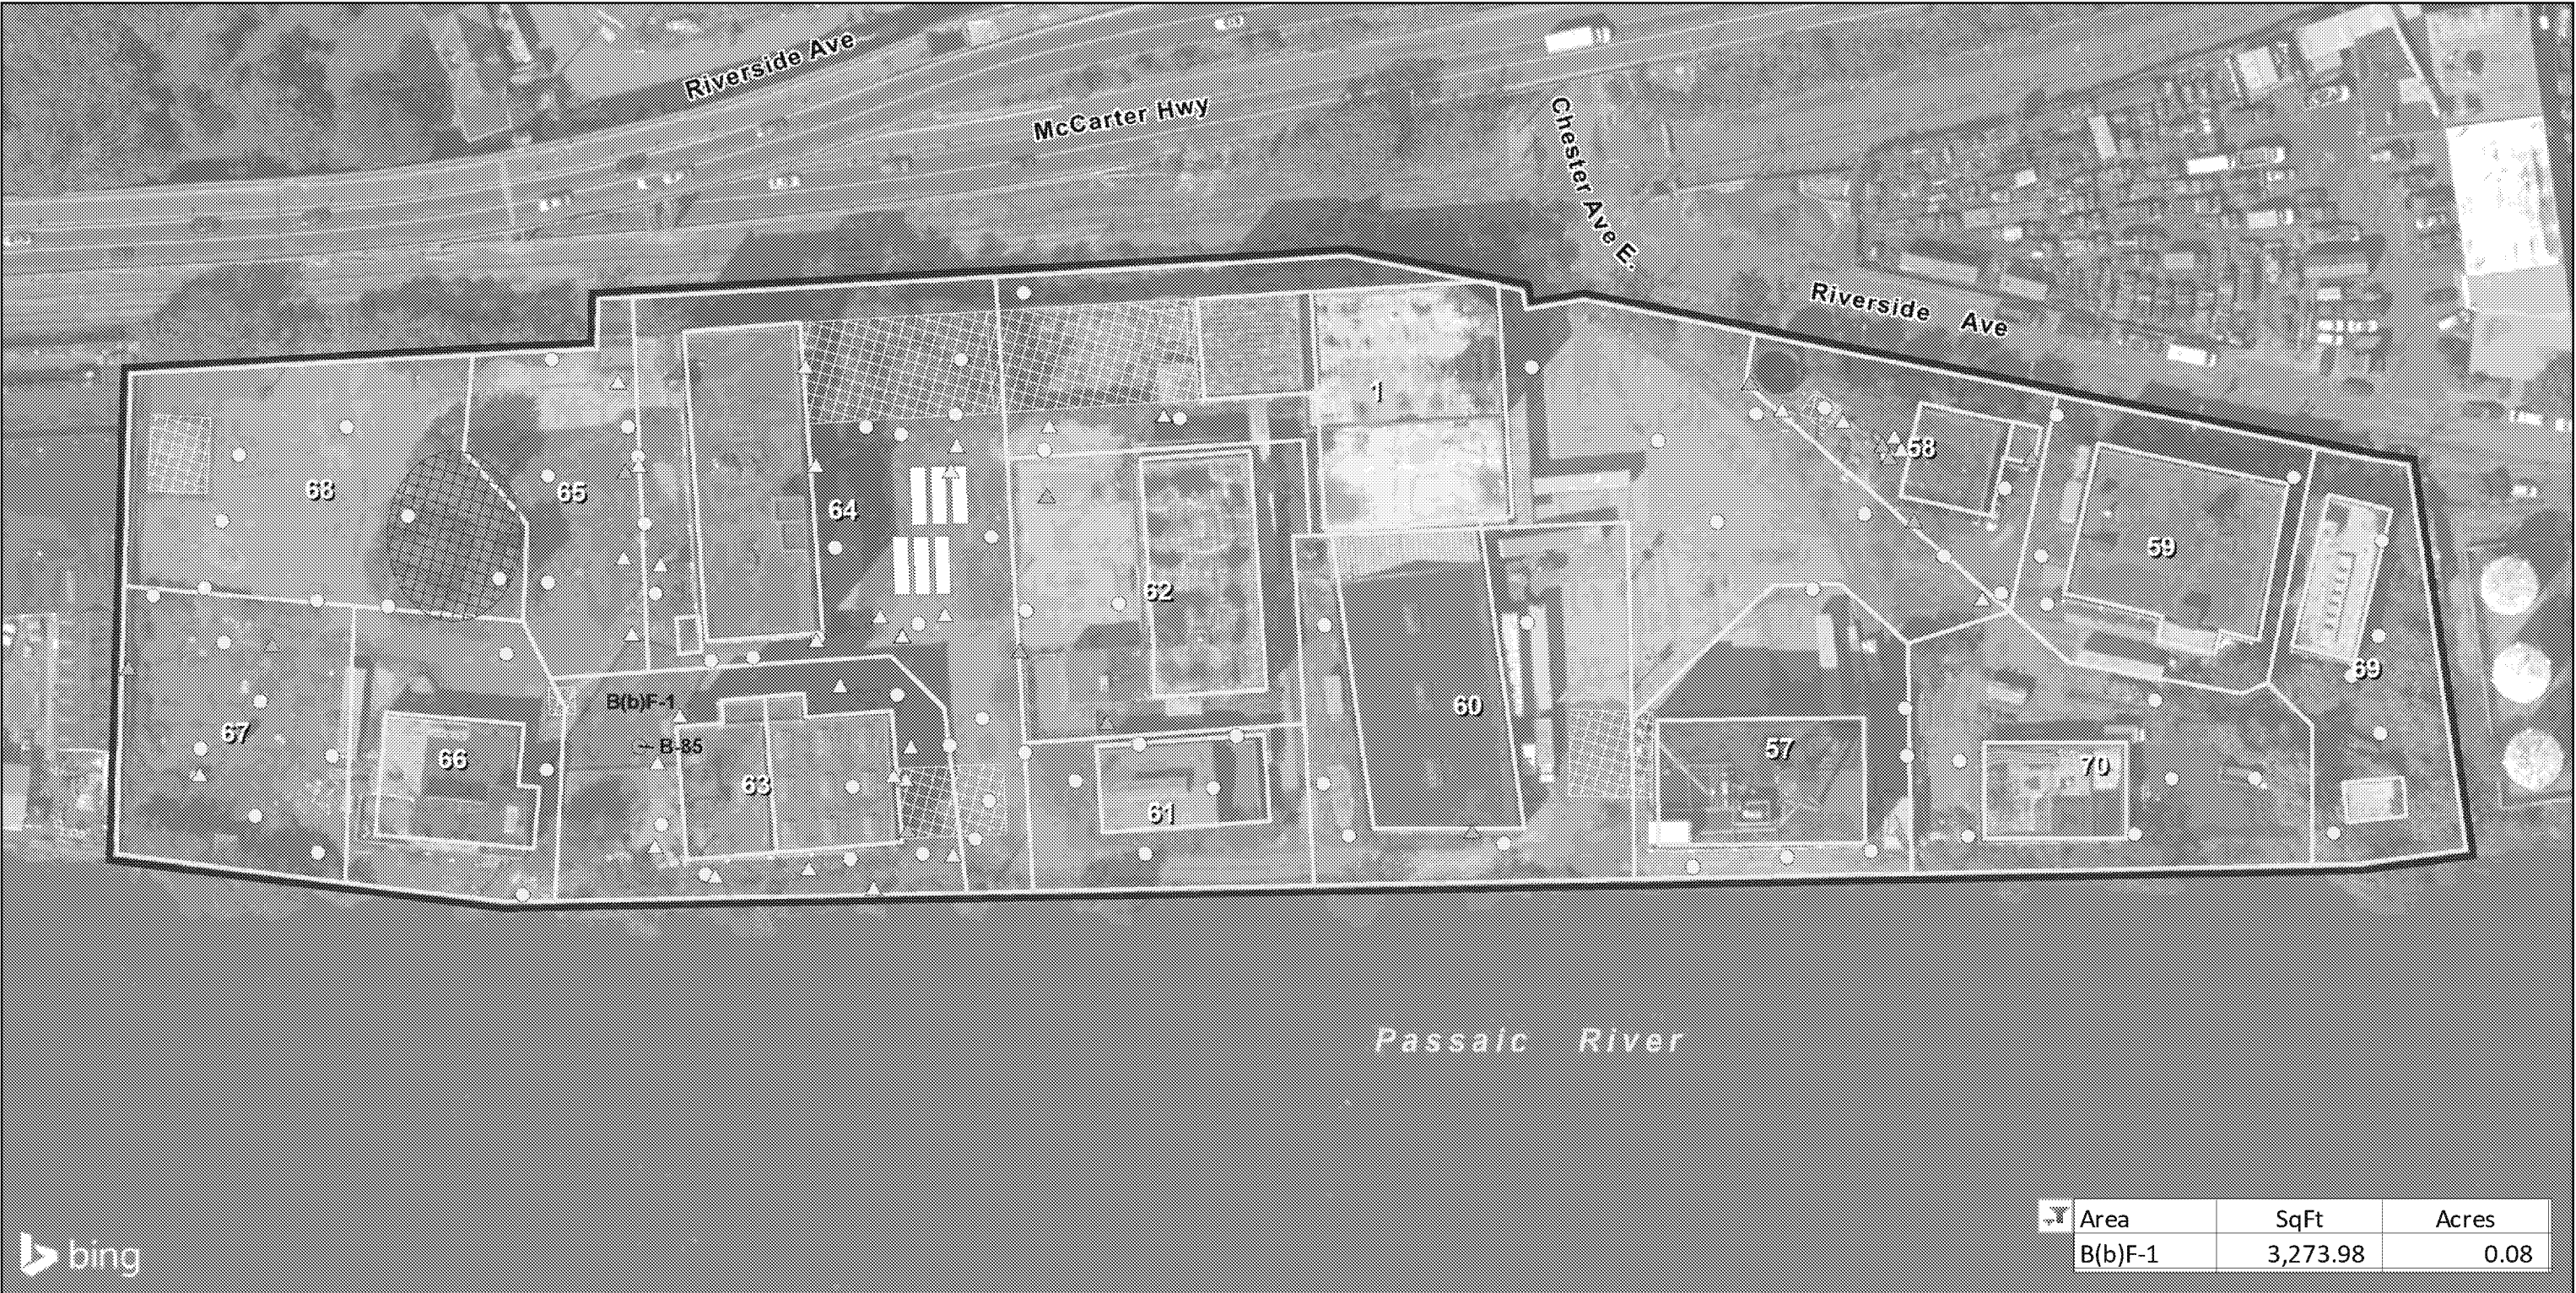
Figure A-6

Site-Wide Sampling Results for Soil Alternatives: Benzo(b)fluoranthene

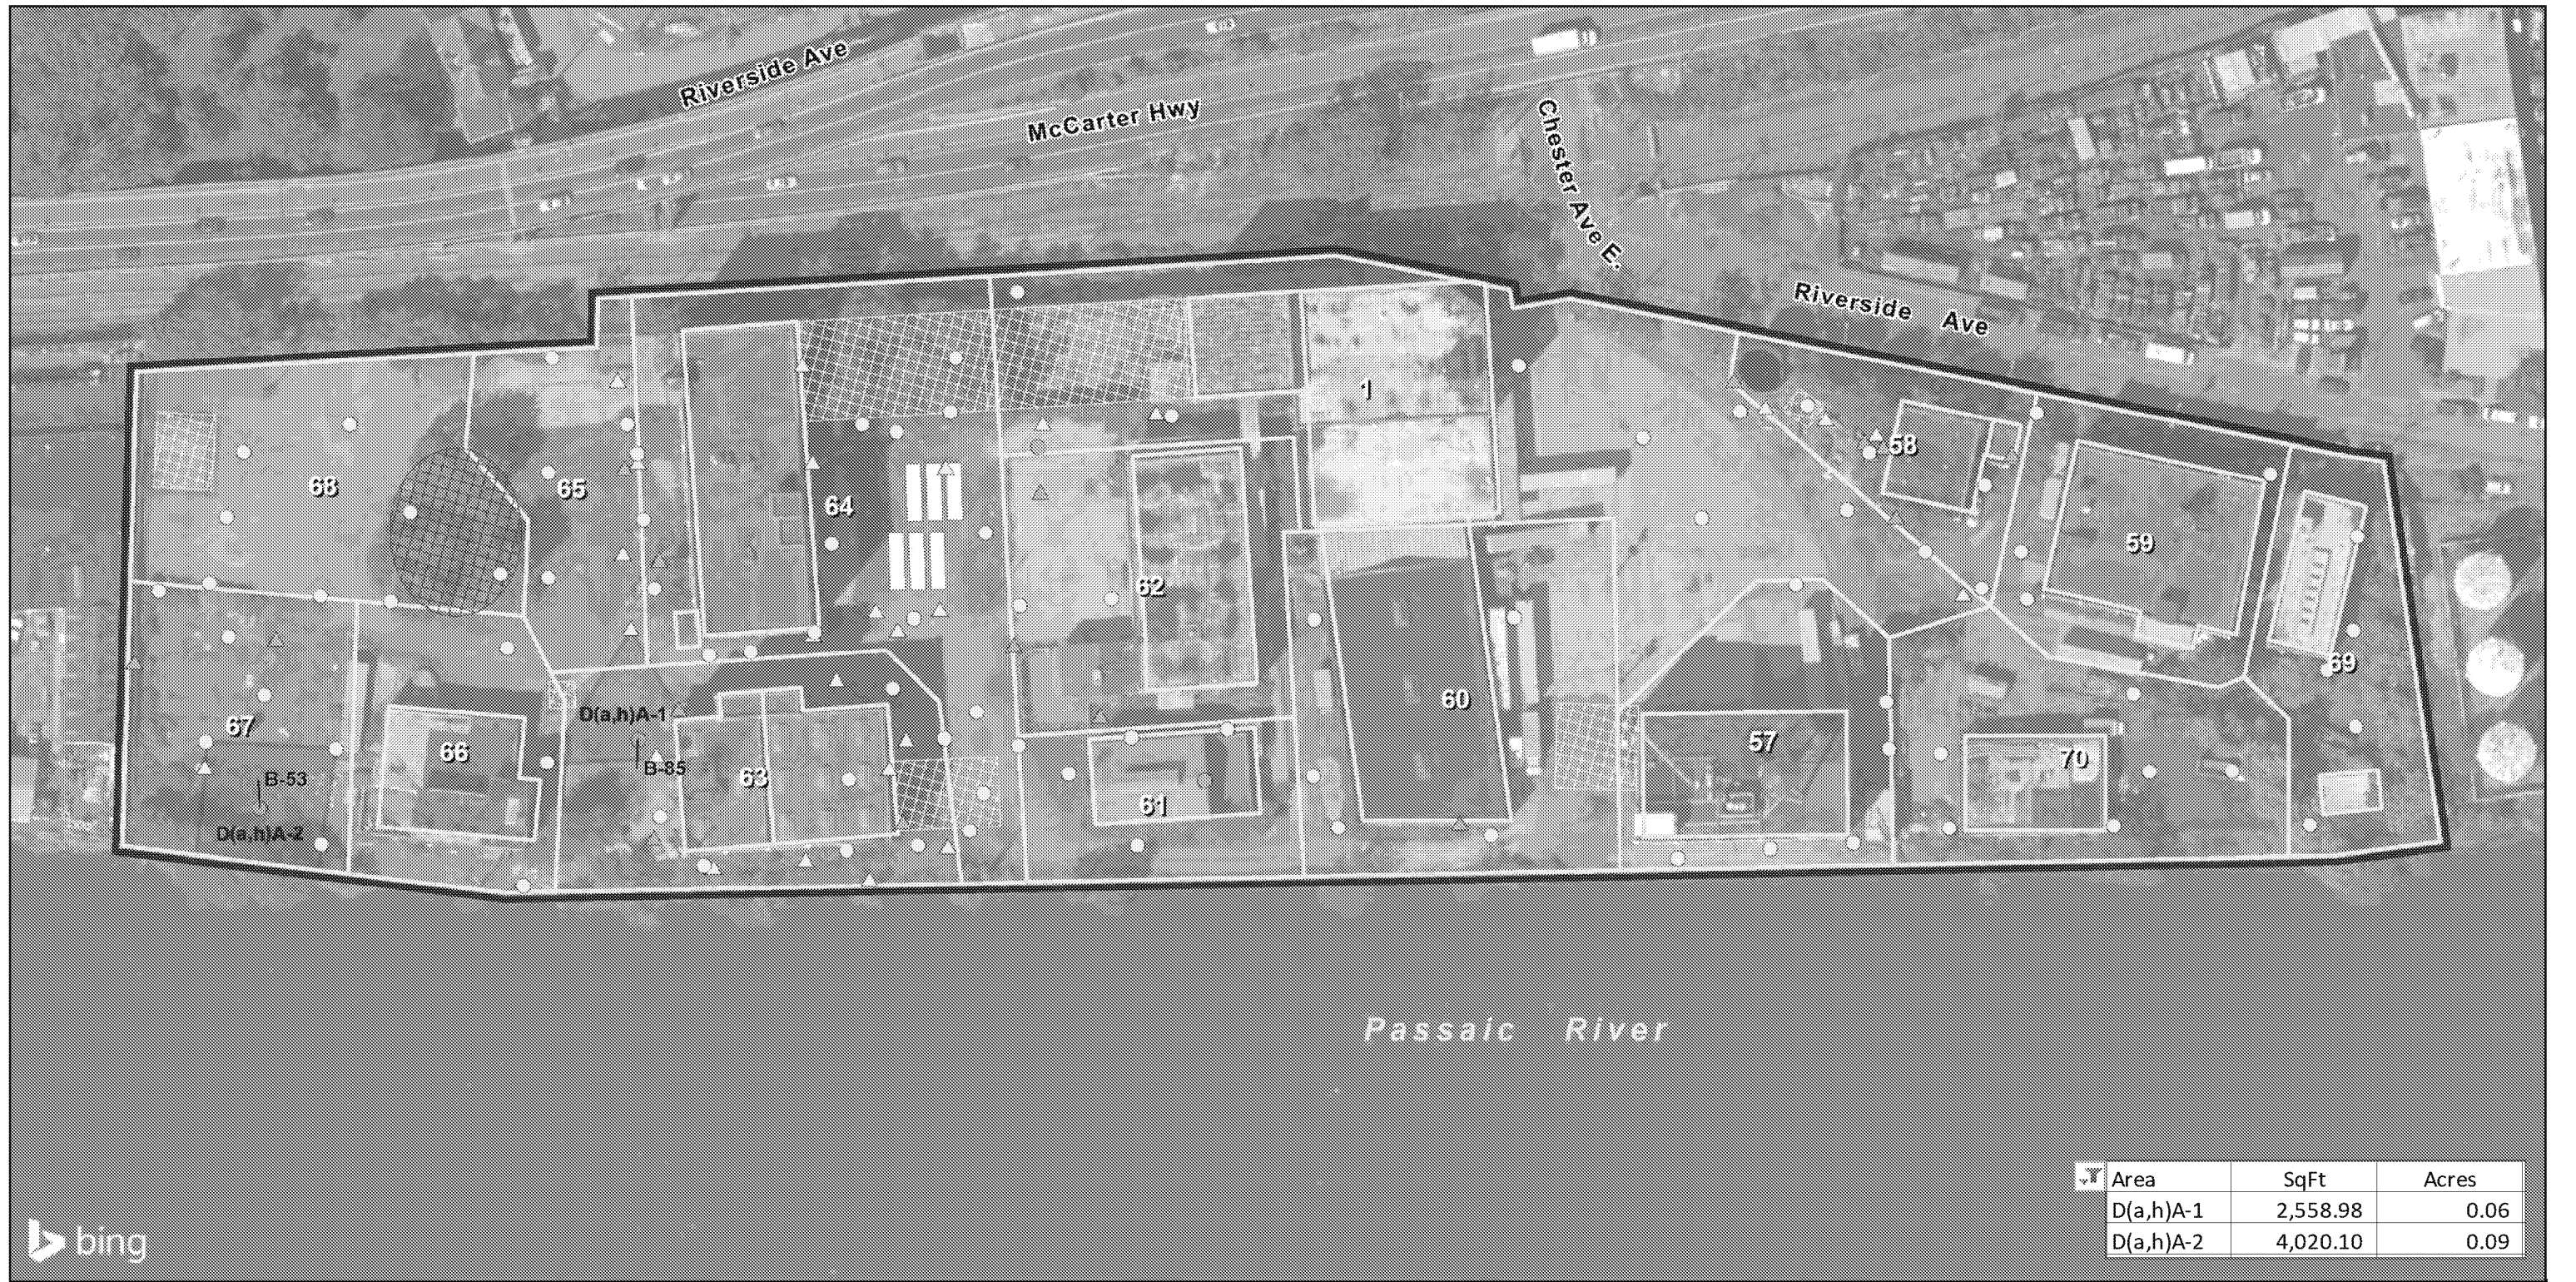
Figure A-7
Site-Wide Sample Results for
Soil Alternatives: Dibenzo(a,h)anthracene
Riverside Industrial Park Superfund Site
Essex County, New Jersey

Area	SqFt	Acres
D(a,h)A-1	2,558.98	0.06
D(a,h)A-2	4,020.10	0.09

Figure	COPCs	Area	SqFt	Acres
Figure A-7	Dibenzo(a,h)anthracene	D(a,h)A-1	2,558.98	0.06
		D(a,h)A-2	4,020.10	0.09
Figure A-8	PCBs (Total)	PCB-1	3,661.67	0.08
		PCB-2	3,311.66	0.08
		PCB-3	7,001.54	0.16
		PCB-4	10,318.49	0.24
Figure A-9	Benzene	Benzene-1	5,206.38	0.12
		Benzene-2	5,205.43	0.12
Figure A-10	Naphthalene	NAPH-1	3,203.09	0.07
Figure A-11	Vinyl Chloride	VC-1	2,935.72	0.07
		VC-2	4,084.71	0.09
Figure A-12	Footprint of the Soil/Fill Remedial Alternative (composite figure of all parameters)		157,654.08	3.62
Figure A-13	Naphthalene	NAPH-1	13671.79	0.31
		NAPH-2	2527.79	0.06
		NAPH-3	8077.46	0.19
		NAPH-4	16078.8	0.37
		NAPH-5	11021.63	0.25
		NAPH-6	2077.04	0.05
		NAPH-7	37278.79	0.86
		NAPH-8	3687.5	0.08
Figure A-14	Trichloroethene	TCE-1	28907.11	0.66
		TCE-2	4532.19	0.1
		TCE-3	51815.44	1.19
		TCE-4	5036.7	0.12
		TCE-5	1742.84	0.04
		TCE-6	23382.09	0.54
Figure A-15	Xylenes (Total)	Xy-1	6832.53	0.16
		Xy-2	3749.6	0.09

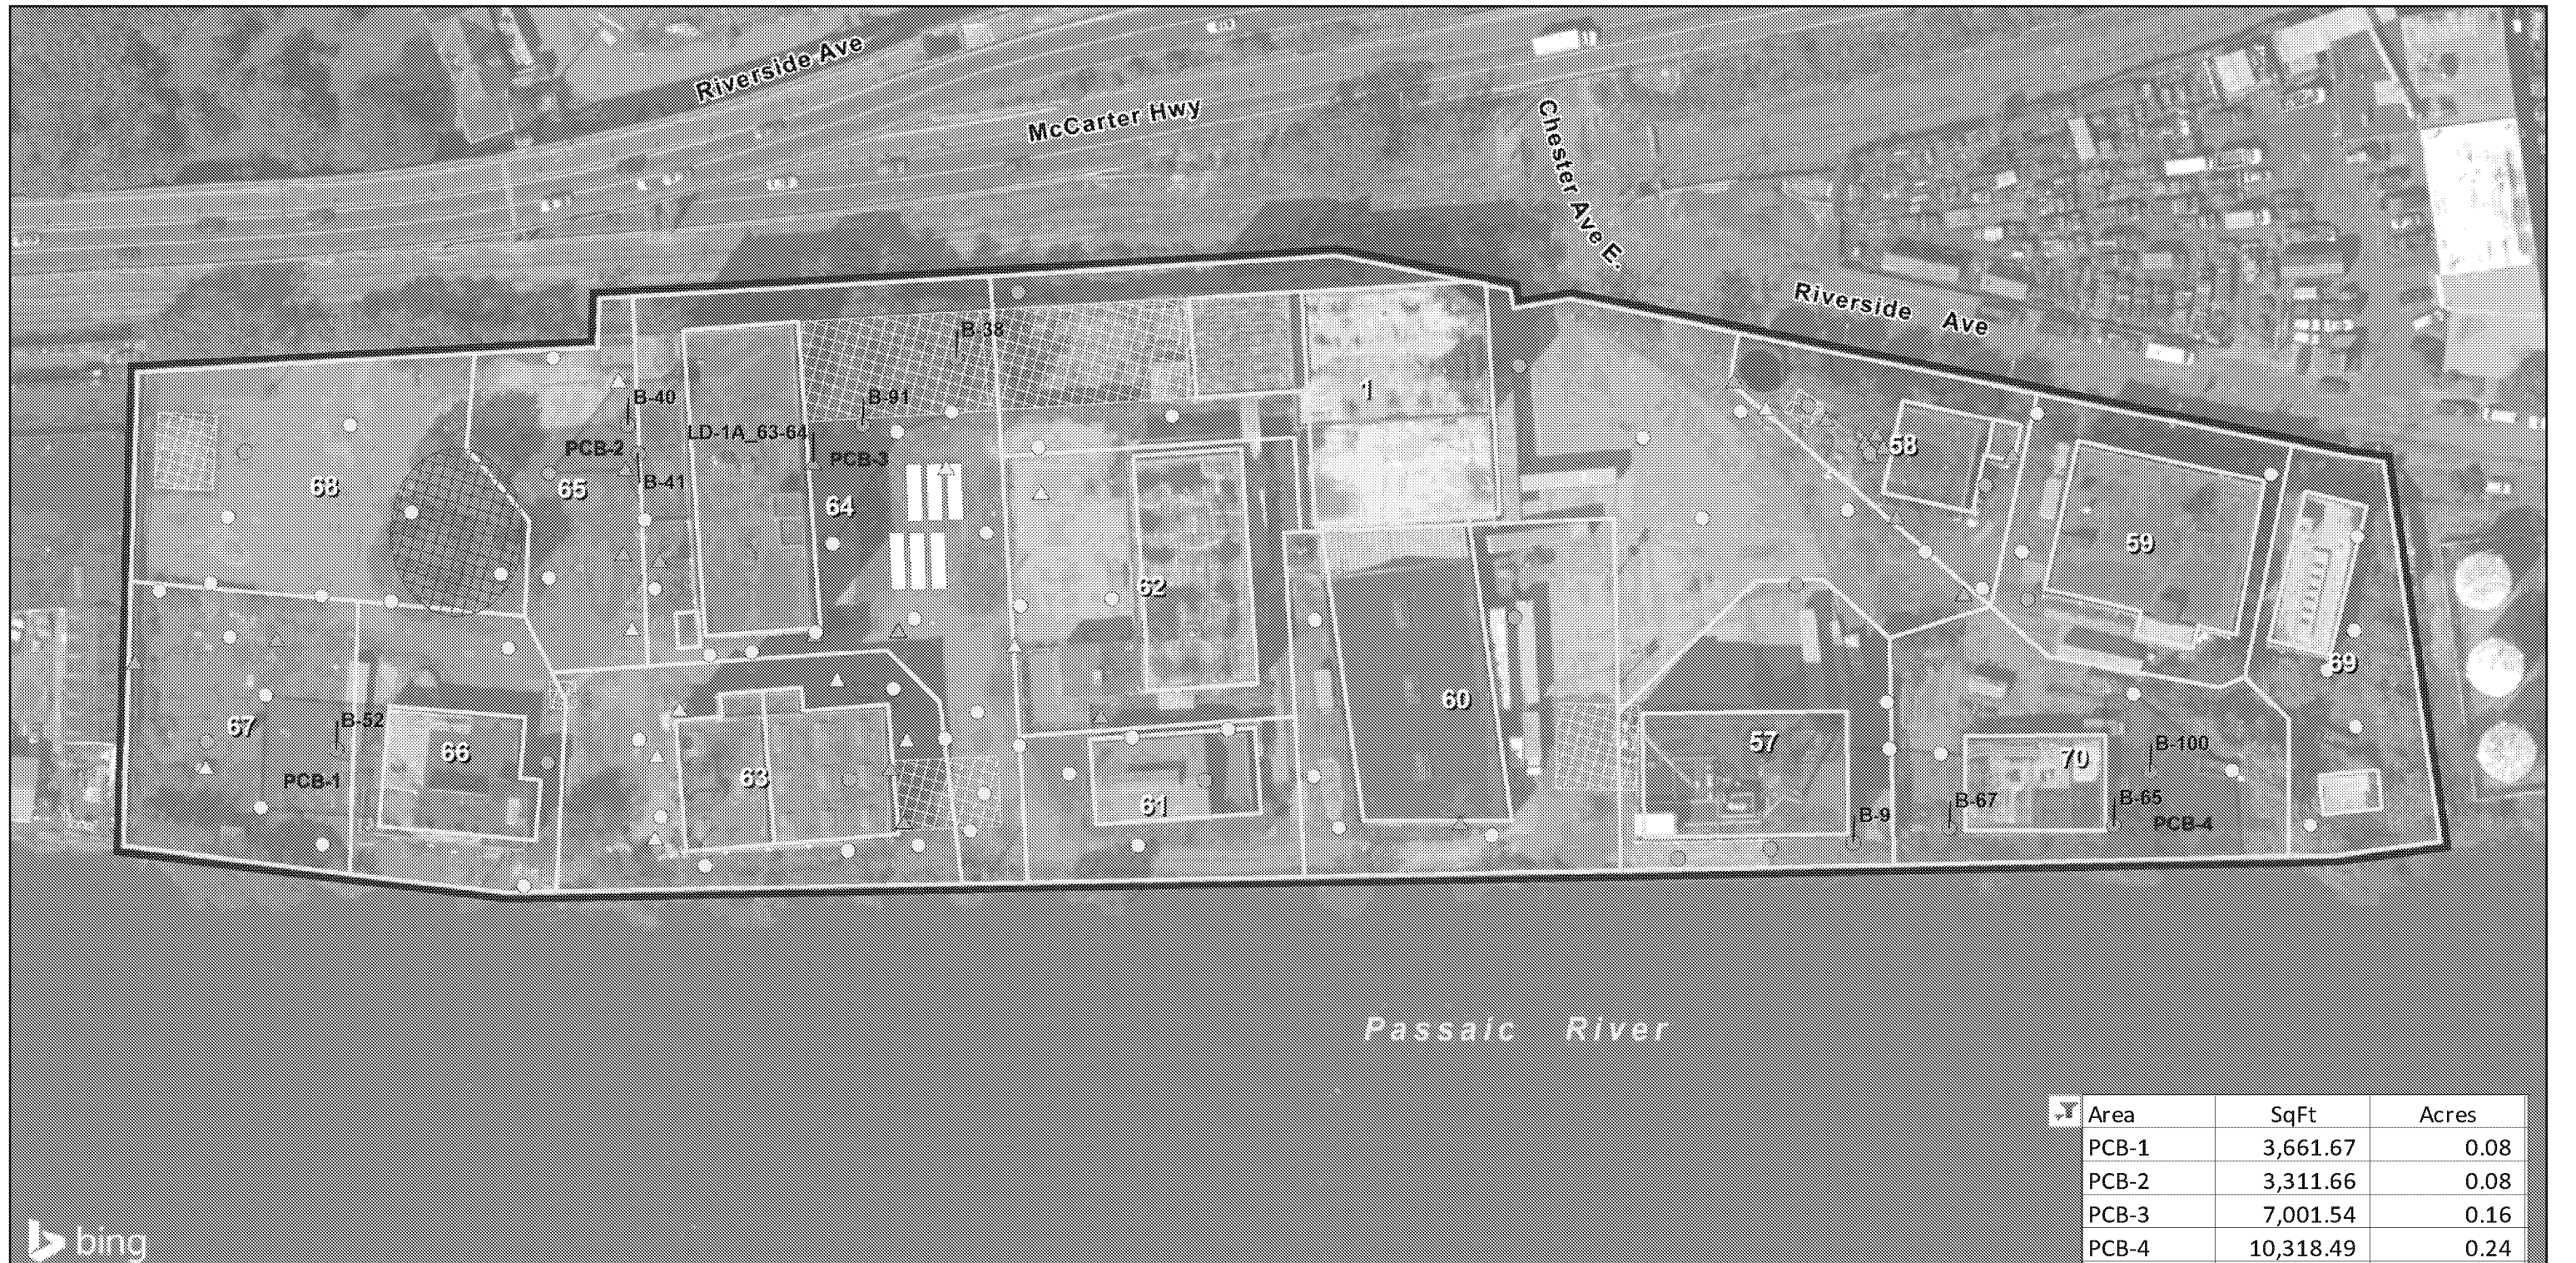
Figure A-8

Area	SqFt	Acres
PCB-1	3,661.67	0.08
PCB-2	3,311.66	0.08
PCB-3	7,001.54	0.16
PCB-4	10,318.49	0.24

Site-Wide Sampling Results for

Soil Alternatives: PCBs (Total)

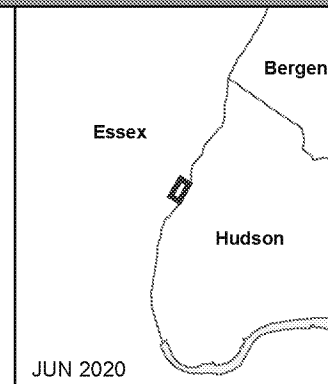
Figure A-9
Site-Wide Soil Sampling Results for
Soil Alternatives: Benzene
Riverside Industrial Park Superfund Site
Essex County, New Jersey

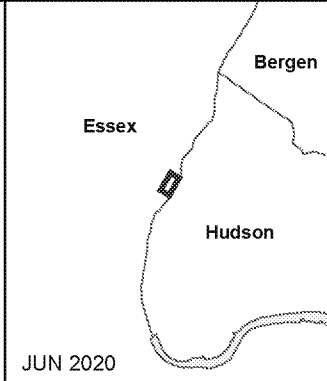
Figure A-10
Site-Wide Sampling Results for
Soil Alternatives: Naphthalene
Riverside Industrial Park Superfund Site
Essex County, New Jersey
